**Flood Control Project Maintenance  
Levee Inspections**

**Fall 2011 Levee Maintenance Deficiency Summary Report**

**Sutter Maintenance Yard Wadsworth Canal**

**Levee Inspection Report By Mile - Fall 2011**

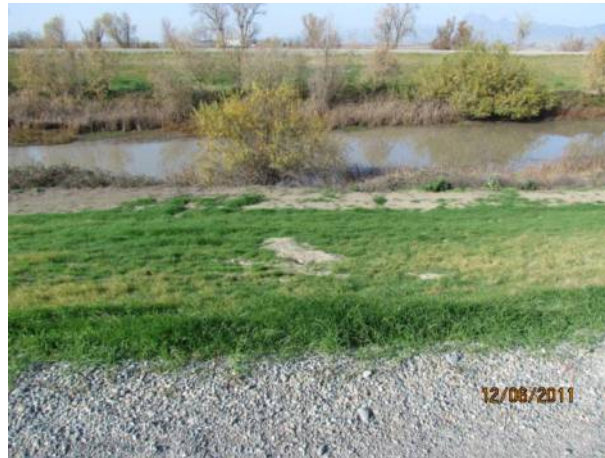
Levee Mile Report Line	1
Start Levee Mile	0.89
End Levee Mile	0.89
Location	Water Side
Category	Earthen Levee
Item	Animal Control

View of the rodent holes along the W/S slope.

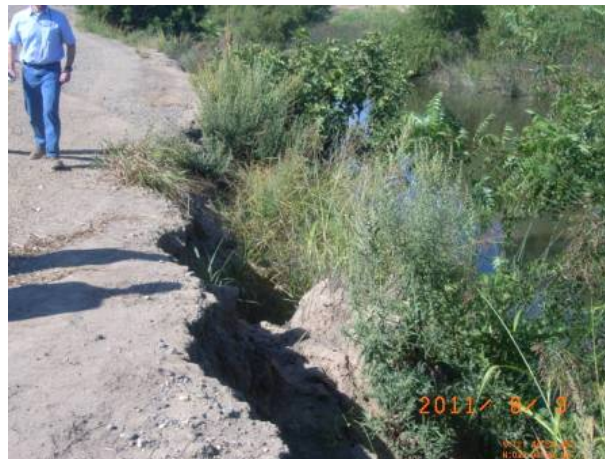
USACE 2011 Photo #1

Levee Mile Report Line	2
Start Levee Mile	1.74
End Levee Mile	1.74
Location	Water Side
Category	Supplemental
Item	USACE Erosion Survey

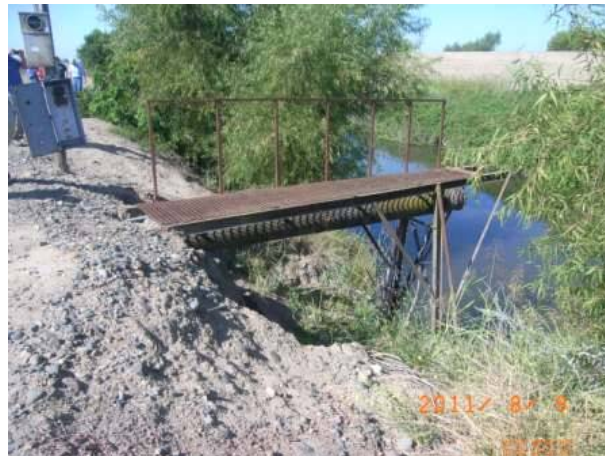
USACE 2011 Photo #2

Levee Mile Report Line	2
Start Levee Mile	1.74
End Levee Mile	1.74
Location	Water Side
Category	Supplemental
Item	USACE Erosion Survey

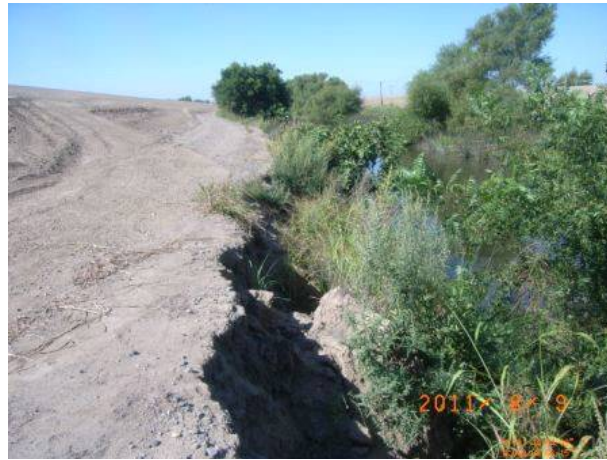
USACE 2011 Photo #3

Levee Mile Report Line	2
Start Levee Mile	1.74
End Levee Mile	1.74
Location	Water Side
Category	Supplemental
Item	USACE Erosion Survey

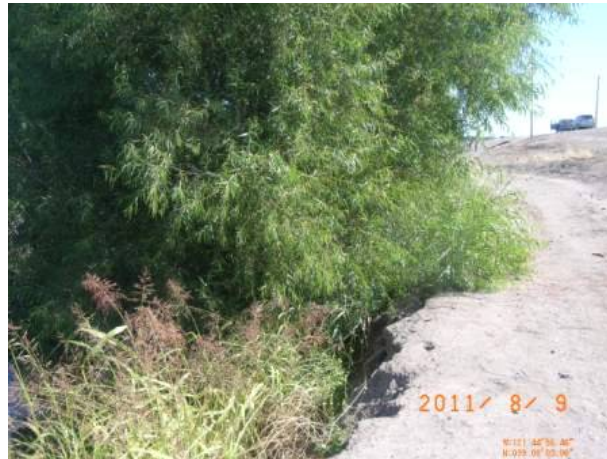
USACE 2011 Photo #4

Levee Mile Report Line	2
Start Levee Mile	1.74
End Levee Mile	1.74
Location	Water Side
Category	Supplemental
Item	USACE Erosion Survey

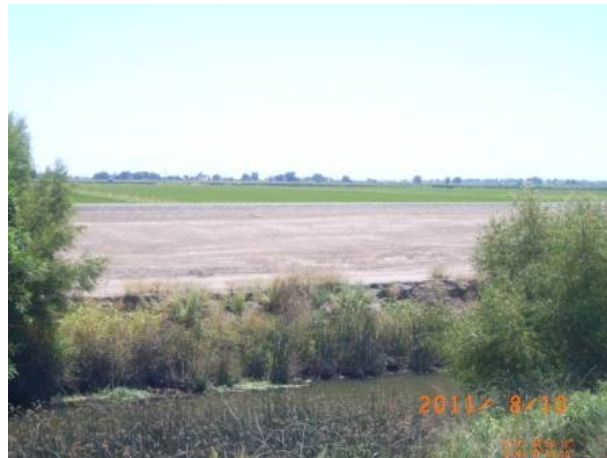
USACE 2011 Photo #5

Levee Mile Report Line	2
Start Levee Mile	1.74
End Levee Mile	1.74
Location	Water Side
Category	Supplemental
Item	USACE Erosion Survey

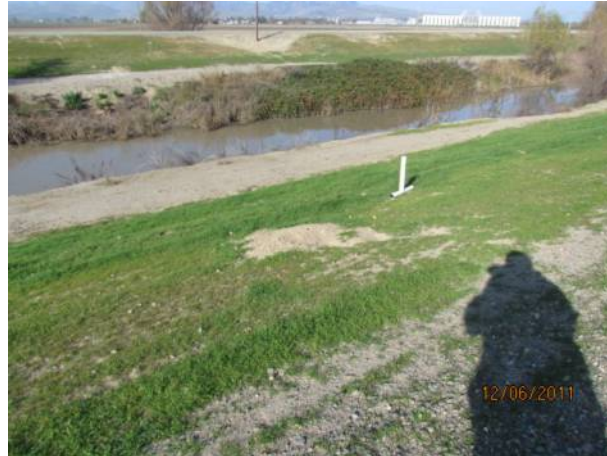
Levee Mile Report Line	3
Start Levee Mile	1.82
End Levee Mile	1.82
Location	Water Side
Category	Earthen Levee
Item	Animal Control

View of the rodent holes & bait station along the W/S slope.

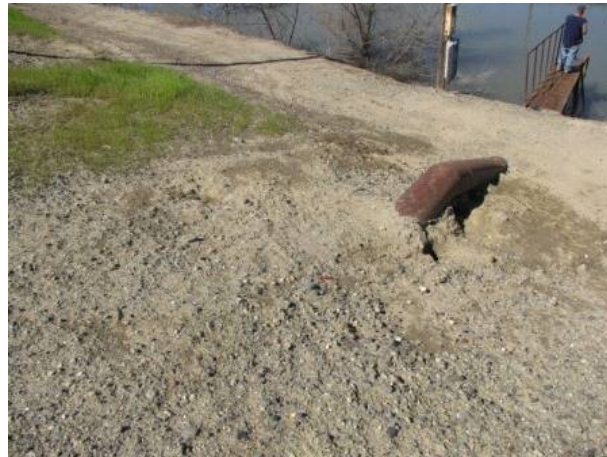
Levee Mile Report Line	4
Start Levee Mile	1.85
End Levee Mile	1.85
Location	Water Side
Category	Earthen Levee
Item	Animal Control

View of rodents burrows along the slope & next to a pipe.

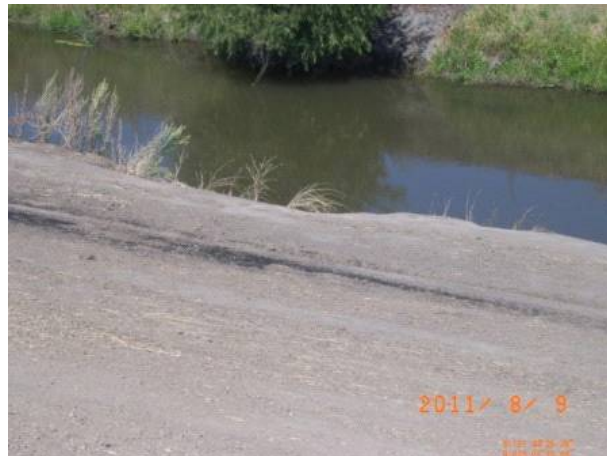
USACE 2011 Photo #1

Levee Mile Report Line	7
Start Levee Mile	2.41
End Levee Mile	2.41
Location	Water Side
Category	Supplemental
Item	USACE Erosion Survey

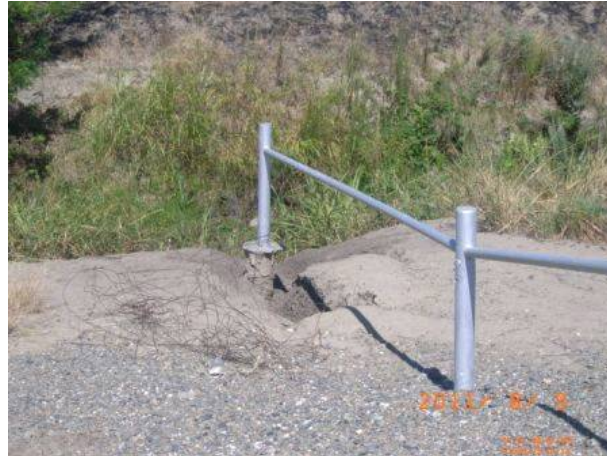
USACE 2011 Photo #2

Levee Mile Report Line	7
Start Levee Mile	2.41
End Levee Mile	2.41
Location	Water Side
Category	Supplemental
Item	USACE Erosion Survey

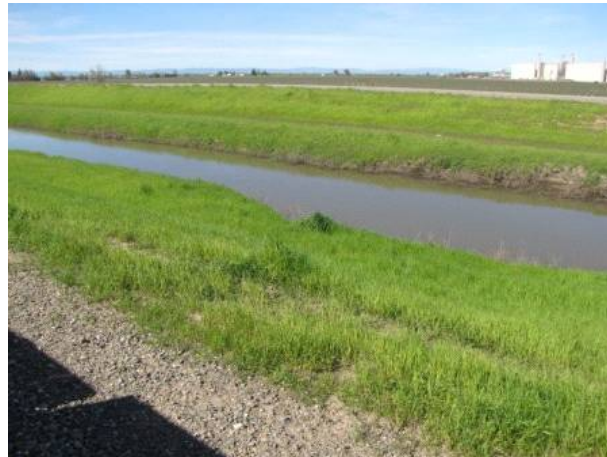
Levee Mile Report Line	8
Start Levee Mile	2.76
End Levee Mile	2.76
Location	Water Side
Category	Earthen Levee
Item	Erosion / Bank Caving

View of erosion along W/S toe.

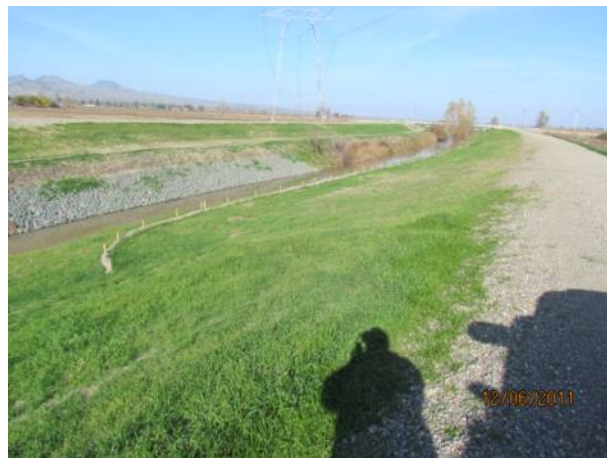
Levee Mile Report Line	9
Start Levee Mile	3.18
End Levee Mile	3.25
Location	Water Side
Category	Earthen Levee
Item	Erosion / Bank Caving

View of the repaired erosion site that Sutter Yard completed.

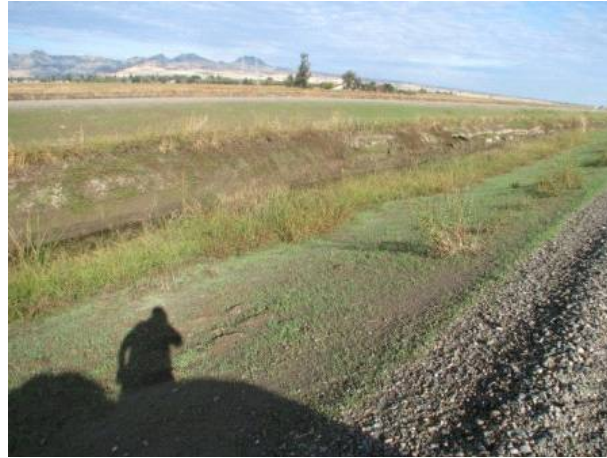
Levee Mile Report Line	11
Start Levee Mile	3.56
End Levee Mile	3.59
Location	Water Side
Category	Earthen Levee
Item	Erosion / Bank Caving

View of the erosion along the waterside toe of the levee.

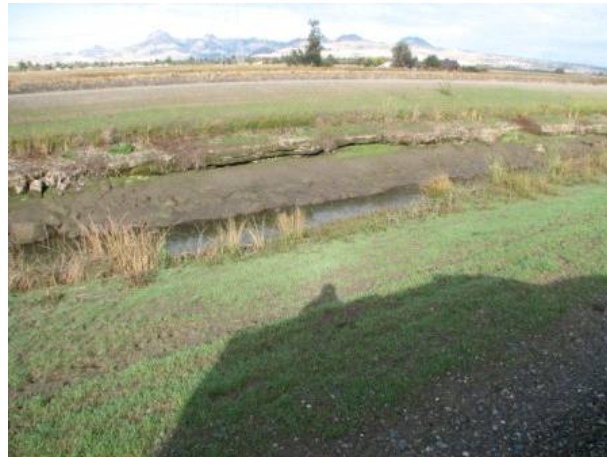
Levee Mile Report Line	12
Start Levee Mile	3.68
End Levee Mile	3.68
Location	Water Side
Category	Earthen Levee
Item	Erosion / Bank Caving

View of the erosion along the waterside toe of the levee.

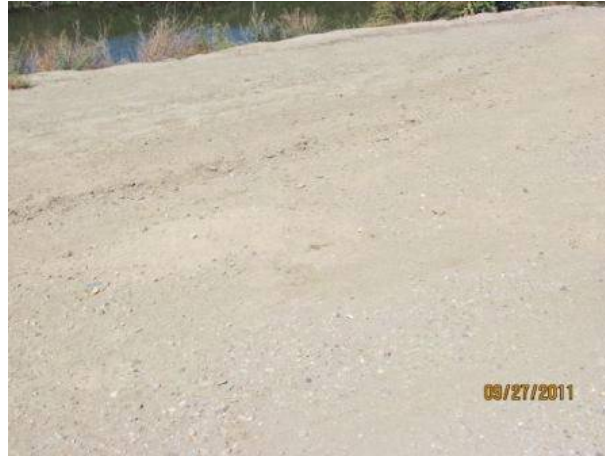
Levee Mile Report Line	2
Start Levee Mile	1.15
End Levee Mile	1.15
Location	Land Side
Category	Earthen Levee
Item	Animal Control

View of the rodent holes along the L/S slope.

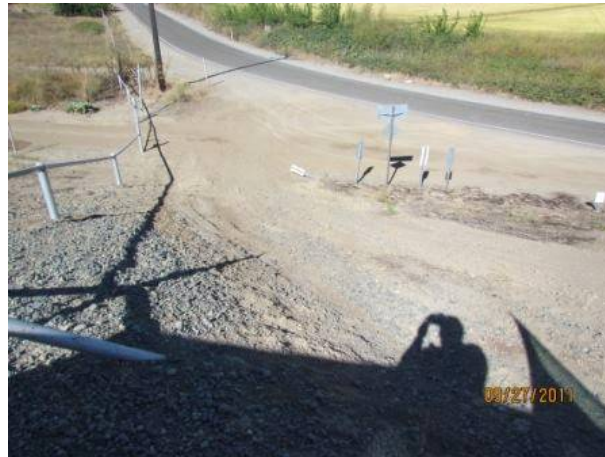
Levee Mile Report Line	3
Start Levee Mile	1.17
End Levee Mile	1.17
Location	Land Side
Category	Earthen Levee
Item	Slope Stability

View of vehicle erosion along L/S slope.

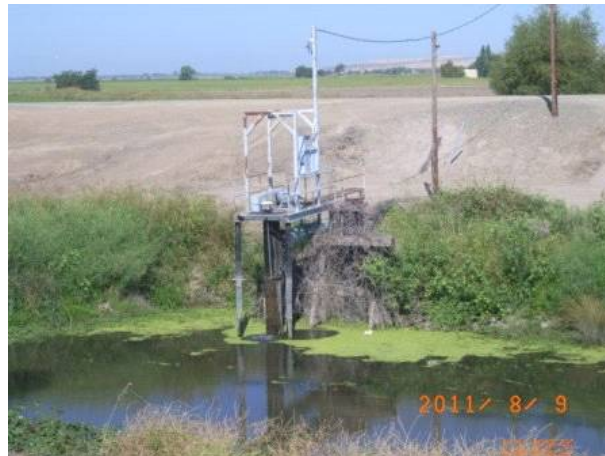
USACE 2011 Photo #1

Levee Mile Report Line	4
Start Levee Mile	1.74
End Levee Mile	1.74
Location	Water Side
Category	Supplemental
Item	USACE Erosion Survey

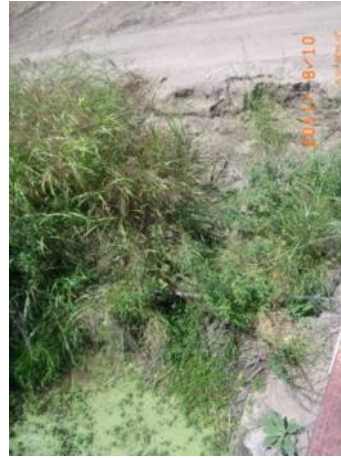
USACE 2011 Photo #2

Levee Mile Report Line	4
Start Levee Mile	1.74
End Levee Mile	1.74
Location	Water Side
Category	Supplemental
Item	USACE Erosion Survey

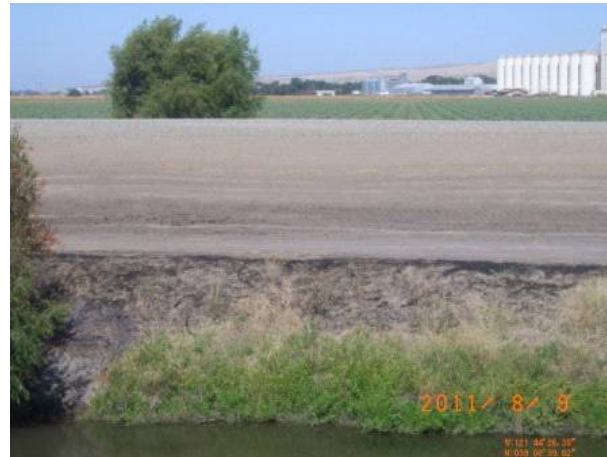
USACE 2011 Photo #1

Levee Mile Report Line	6
Start Levee Mile	2.37
End Levee Mile	2.37
Location	Water Side
Category	Supplemental
Item	USACE Erosion Survey

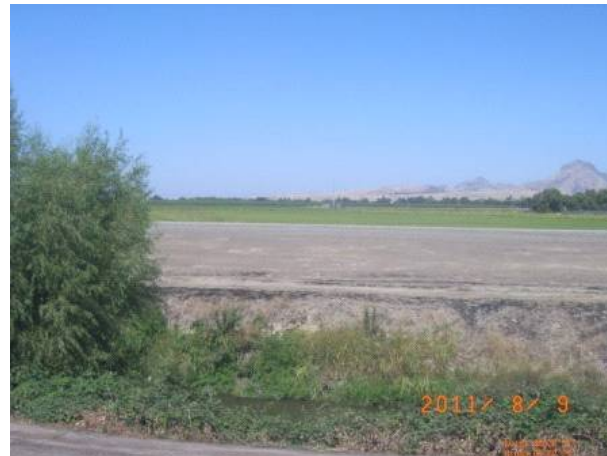
USACE 2011 Photo #2

Levee Mile Report Line	6
Start Levee Mile	2.37
End Levee Mile	2.37
Location	Water Side
Category	Supplemental
Item	USACE Erosion Survey

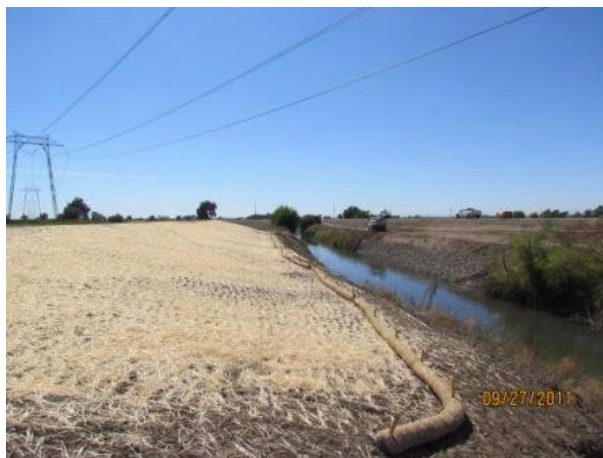
Levee Mile Report Line	7
Start Levee Mile	3.21
End Levee Mile	3.21
Location	Water Side
Category	Earthen Levee
Item	Erosion / Bank Caving

View of the repaired erosion site that Sutter Yard completed.

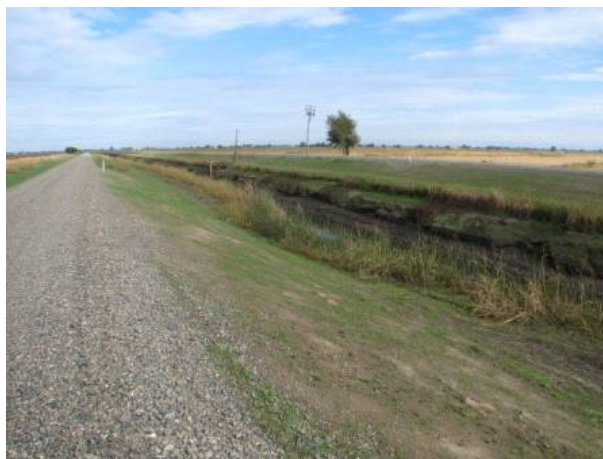
Levee Mile Report Line	9
Start Levee Mile	3.46
End Levee Mile	3.46
Location	Water Side
Category	Earthen Levee
Item	Erosion / Bank Caving

View of the erosion at the waterside toe of the levee.

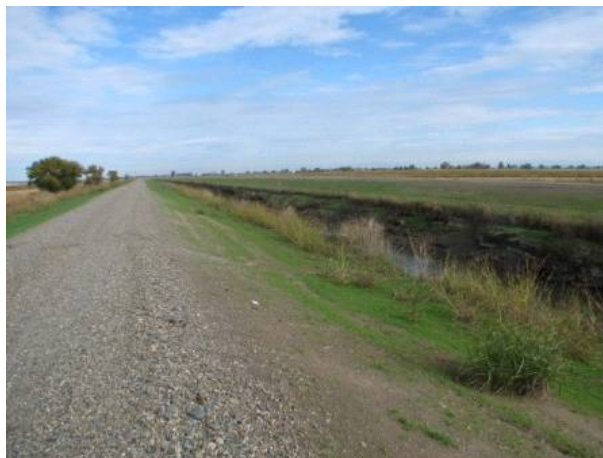
Levee Mile Report Line	10
Start Levee Mile	3.59
End Levee Mile	3.99
Location	Water Side
Category	Earthen Levee
Item	Erosion / Bank Caving

View of the erosion along the waterside toe.

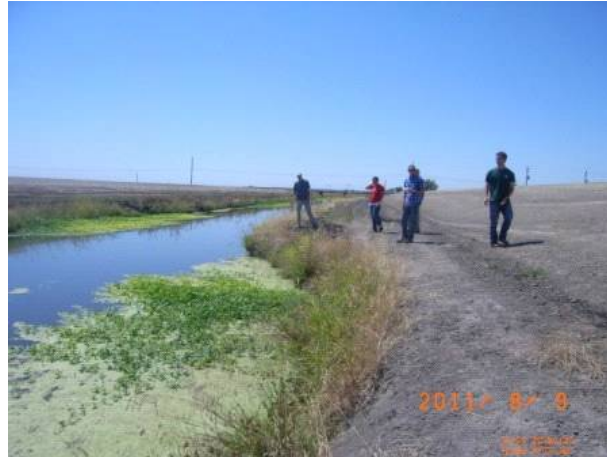
USACE 2011 Photo #1

Levee Mile Report Line	11
Start Levee Mile	4.48
End Levee Mile	4.48
Location	Water Side
Category	Supplemental
Item	USACE Erosion Survey

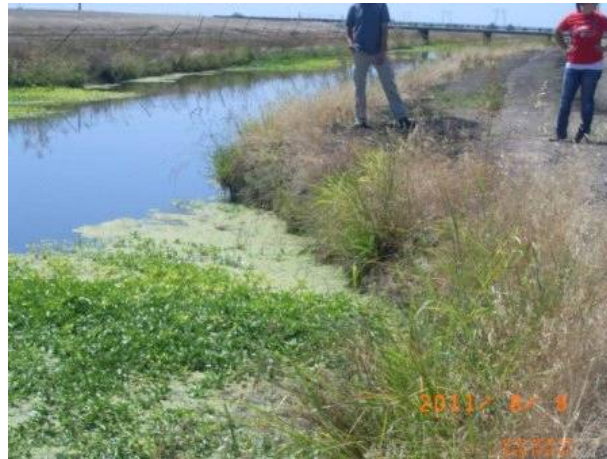
USACE 2011 Photo #2

Levee Mile Report Line	11
Start Levee Mile	4.48
End Levee Mile	4.48
Location	Water Side
Category	Supplemental
Item	USACE Erosion Survey

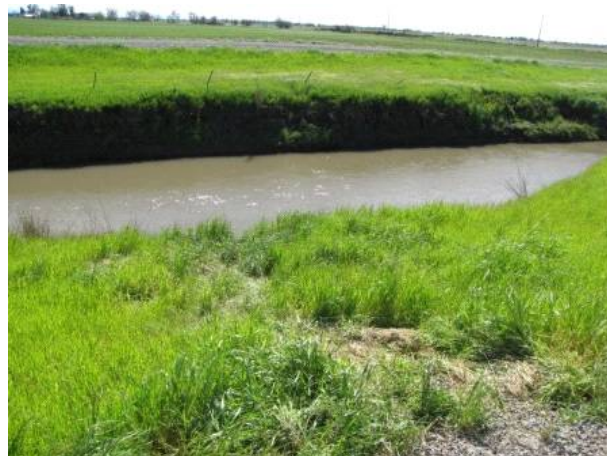
Levee Mile Report Line	12
Start Levee Mile	4.49
End Levee Mile	4.49
Location	Water Side
Category	Earthen Levee
Item	Erosion / Bank Caving

View of erosion along the W/S toe.

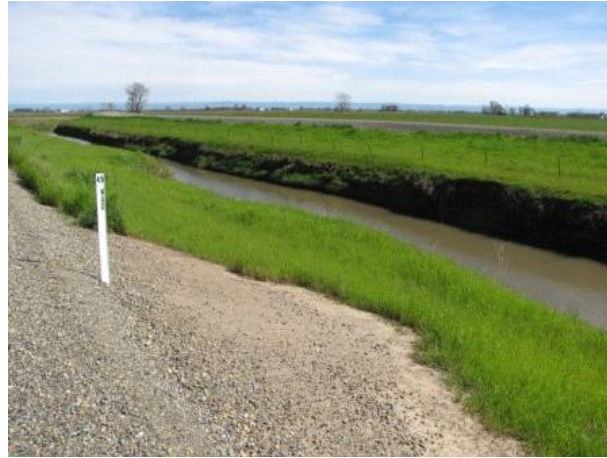
Levee Mile Report Line	13
Start Levee Mile	4.55
End Levee Mile	4.55
Location	Water Side
Category	Earthen Levee
Item	Erosion / Bank Caving

View of the erosion along the W/S toe.
